Software-Update VAS 6565 / VAS 6565A

Failed to update the software / update the loading parameters

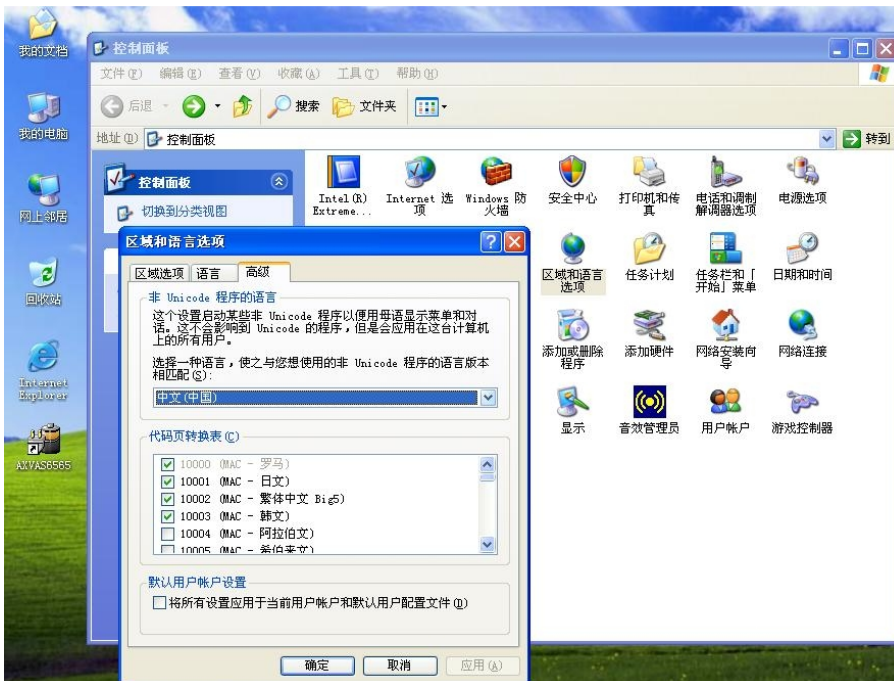
Thereby an error for non-European PC Systems was detected. These systems do not recognize European characters. These must be set by the users themselves. Therefore assumed defects can be excluded absolutely.

1) Open Control panels window and select Regional settings. Select third tab.
